CARLSBAD INN VACATION OWNERS ASSOCIATION

WATERPROOFING EVALUATION STUDY

NOVEMBER 22, 2017

RE: Carlsbad Inn Waterproofing Evaluation Study

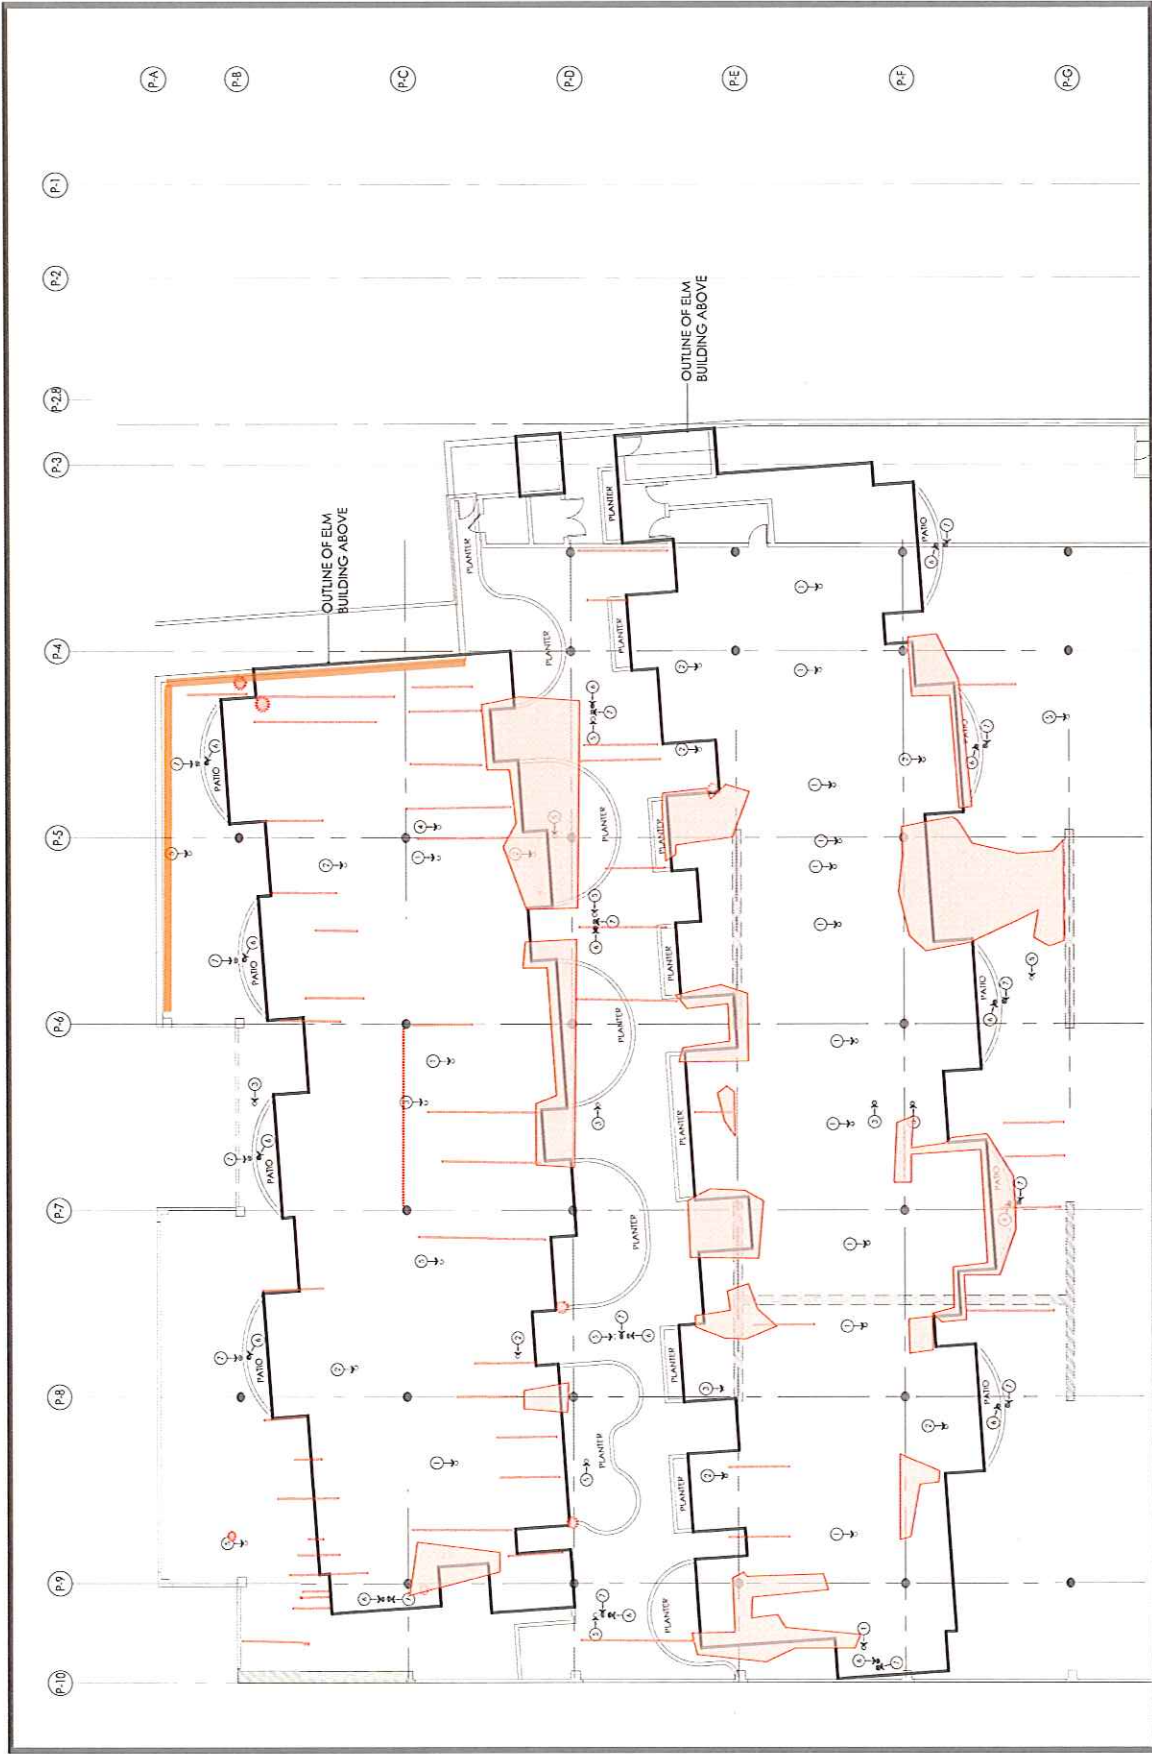
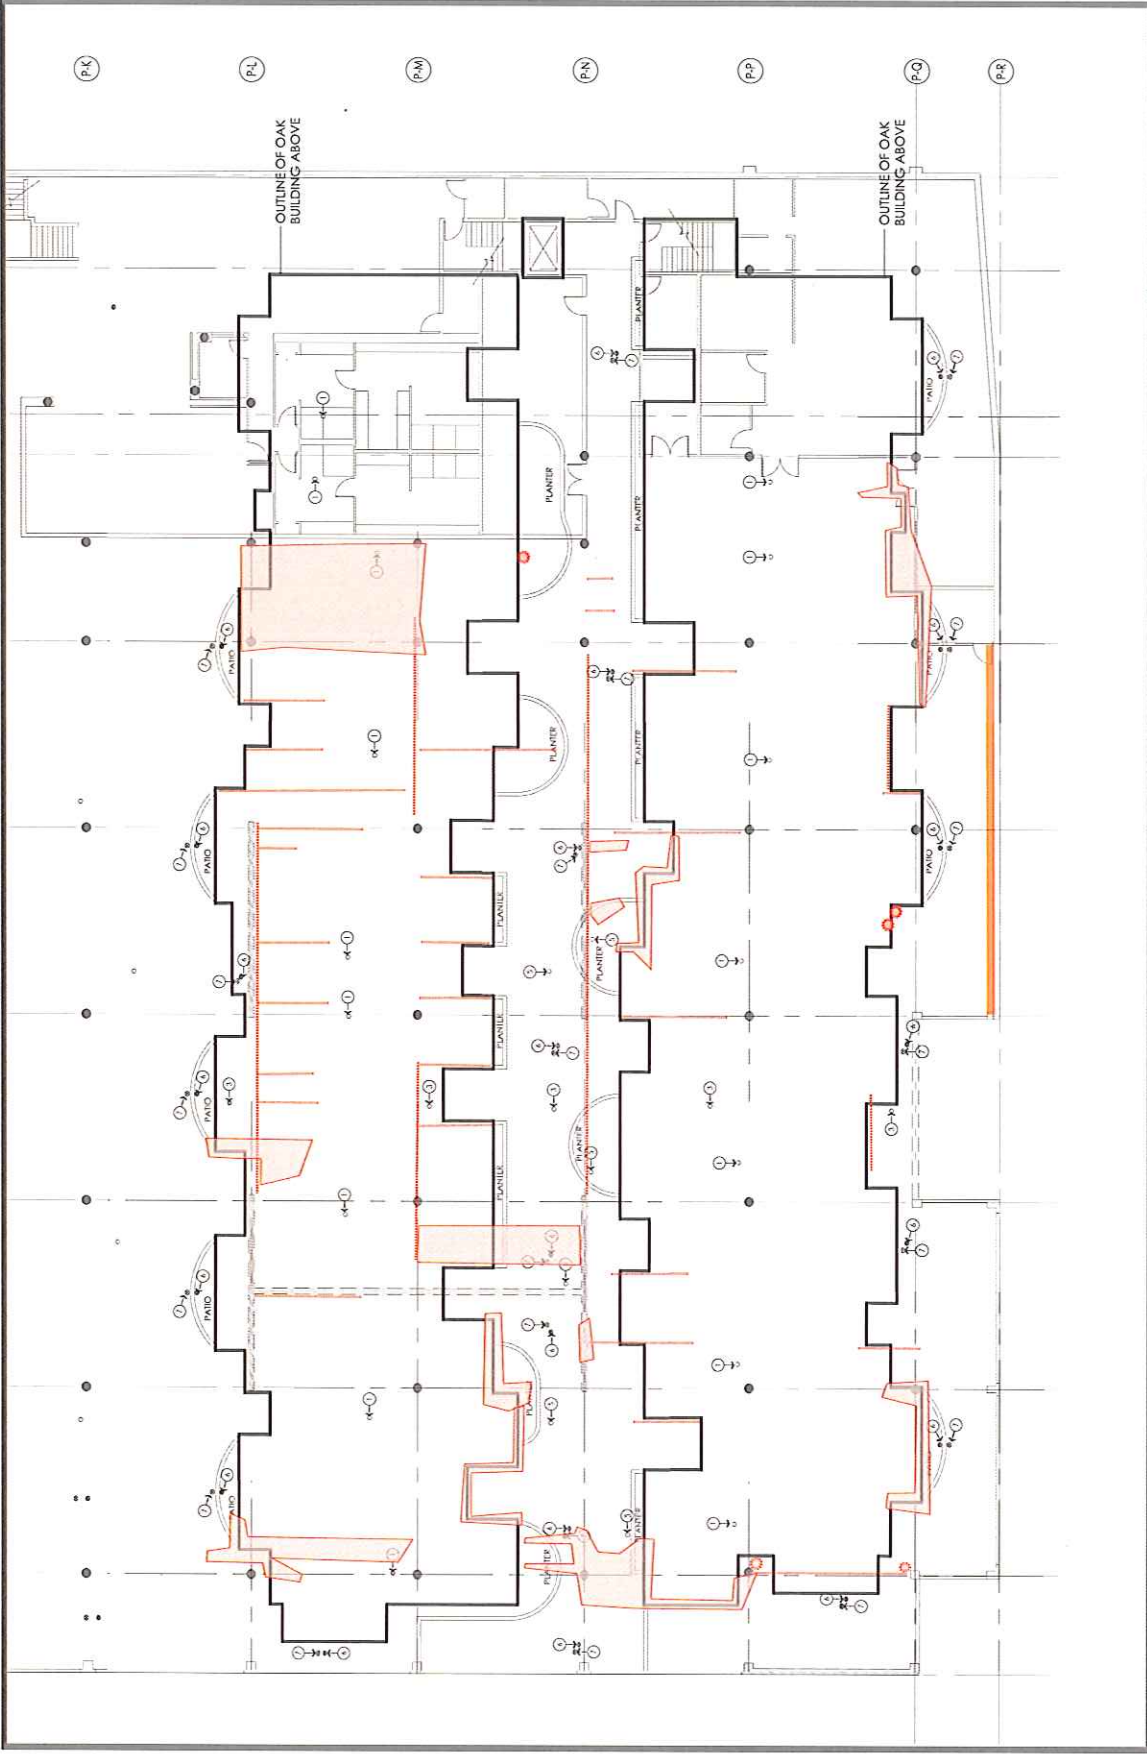
- IV) With this summary memo, we are submitting a preliminary drawing markup of the types of water intrusion observed and their general locations. This will be updated and submitted with the final Phase 1 drawing package.
- V) The determination of sample areas is in process. The final phase 1 drawing package will be submitted, noting water intrusion locations and sample locations, no later than EoD Wednesday, September 20.

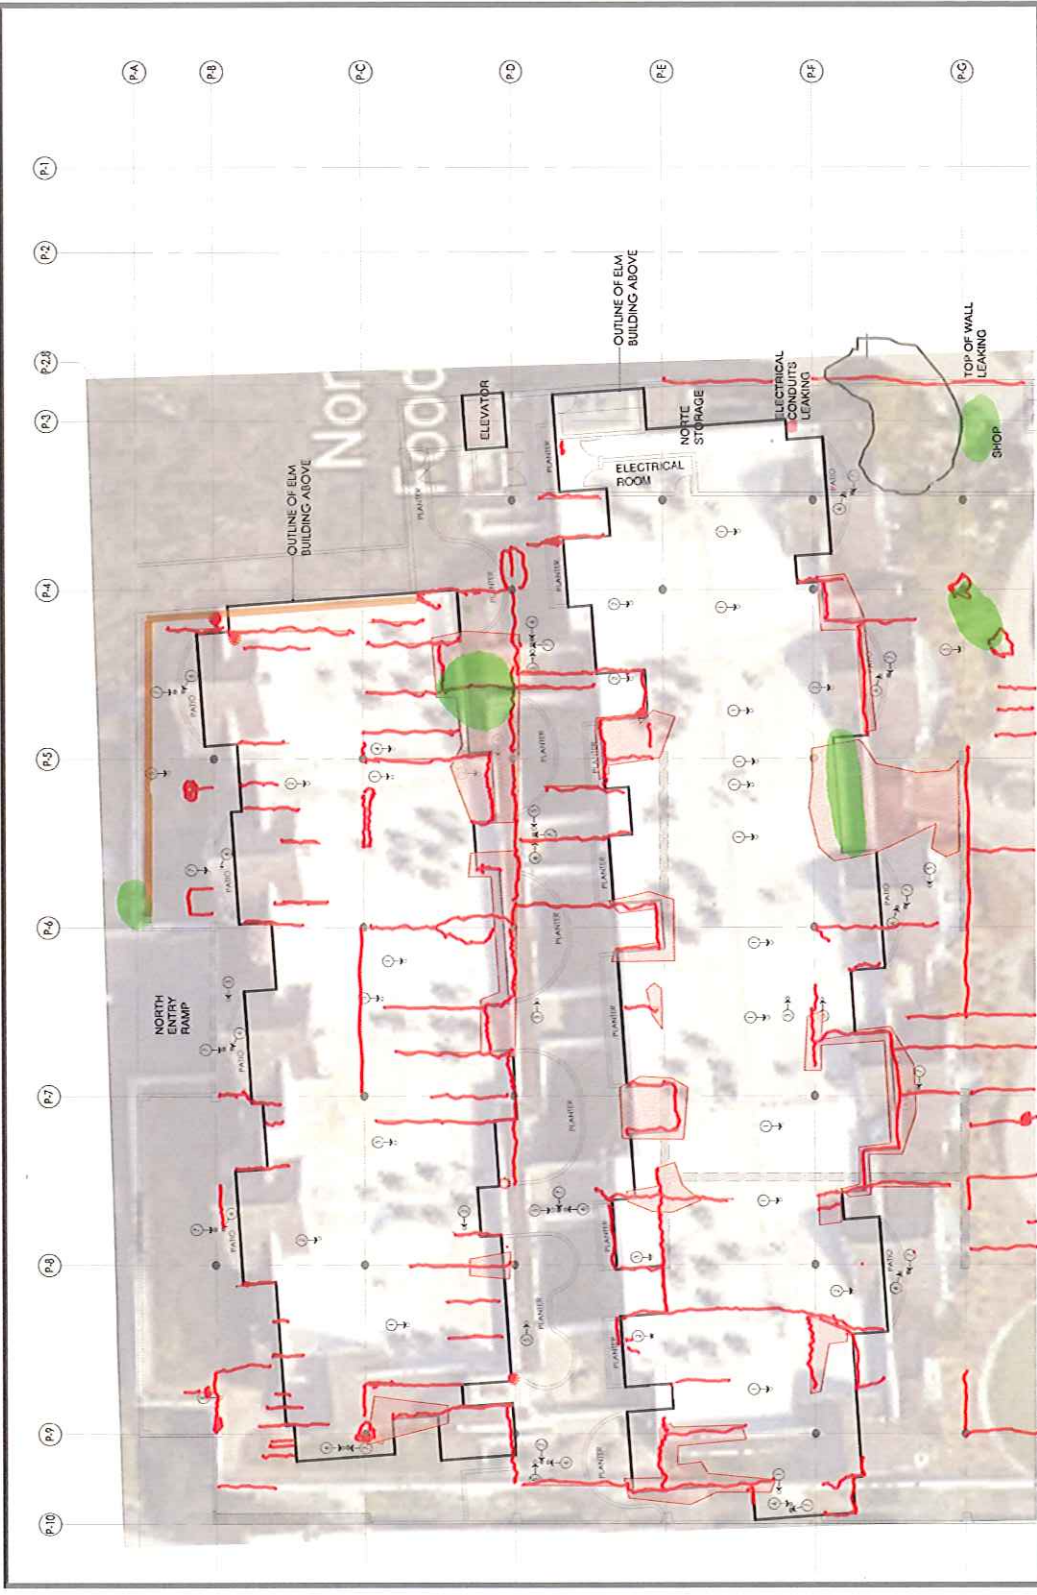
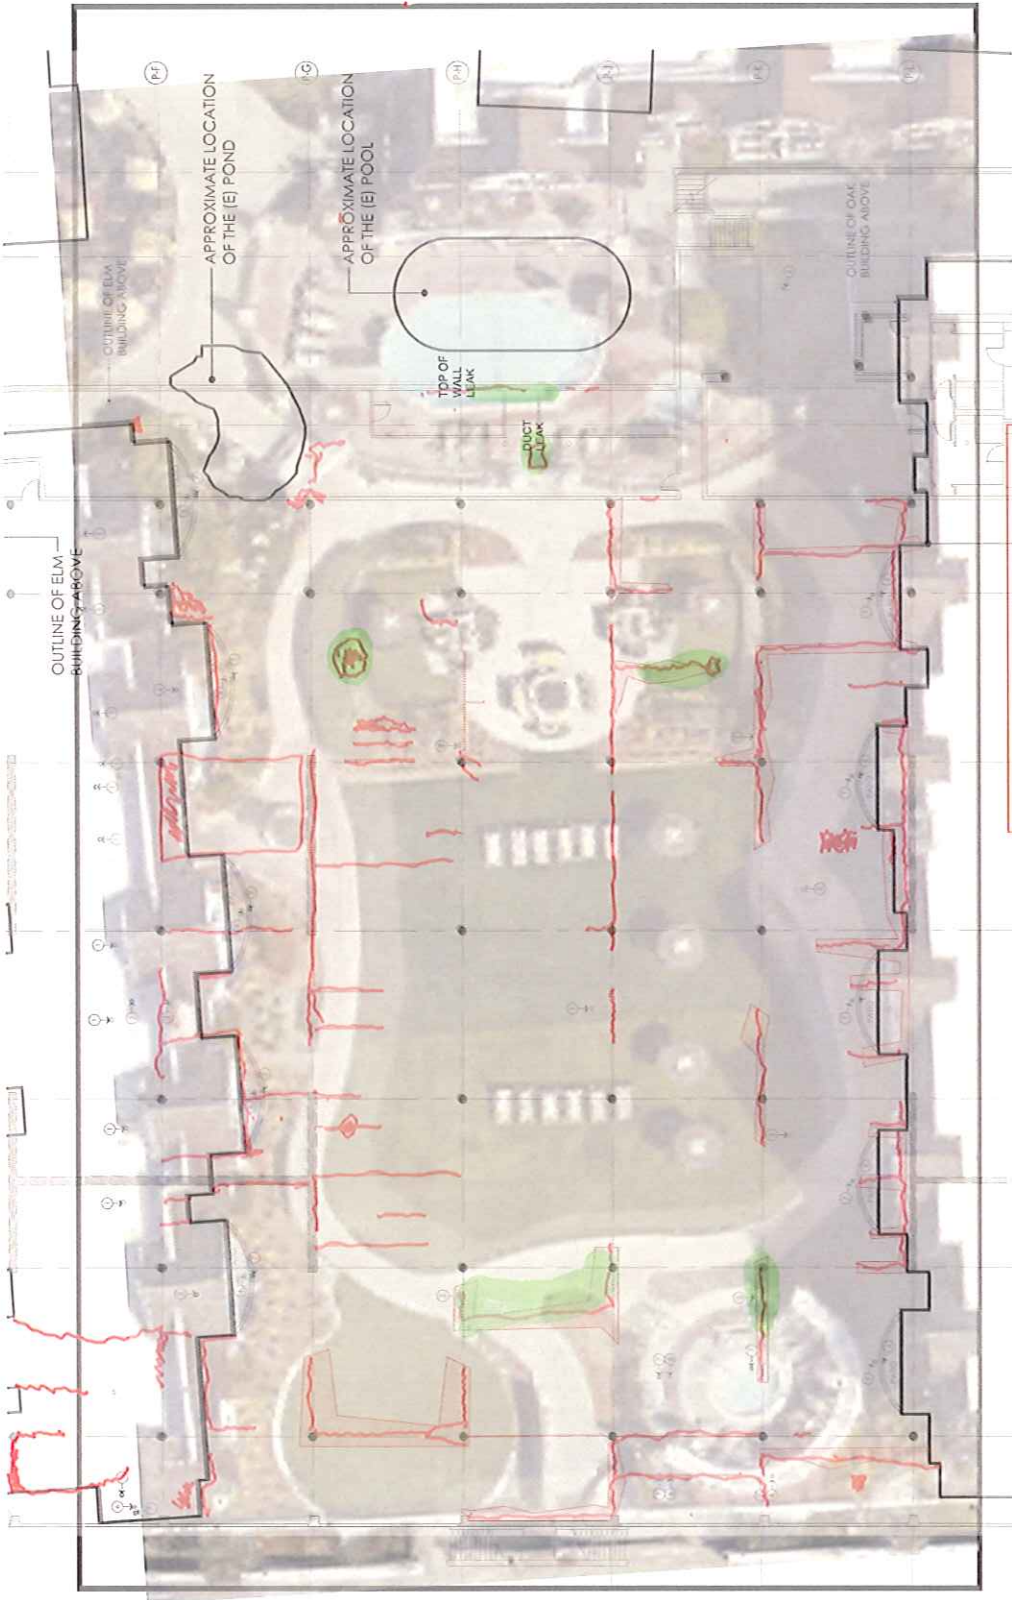
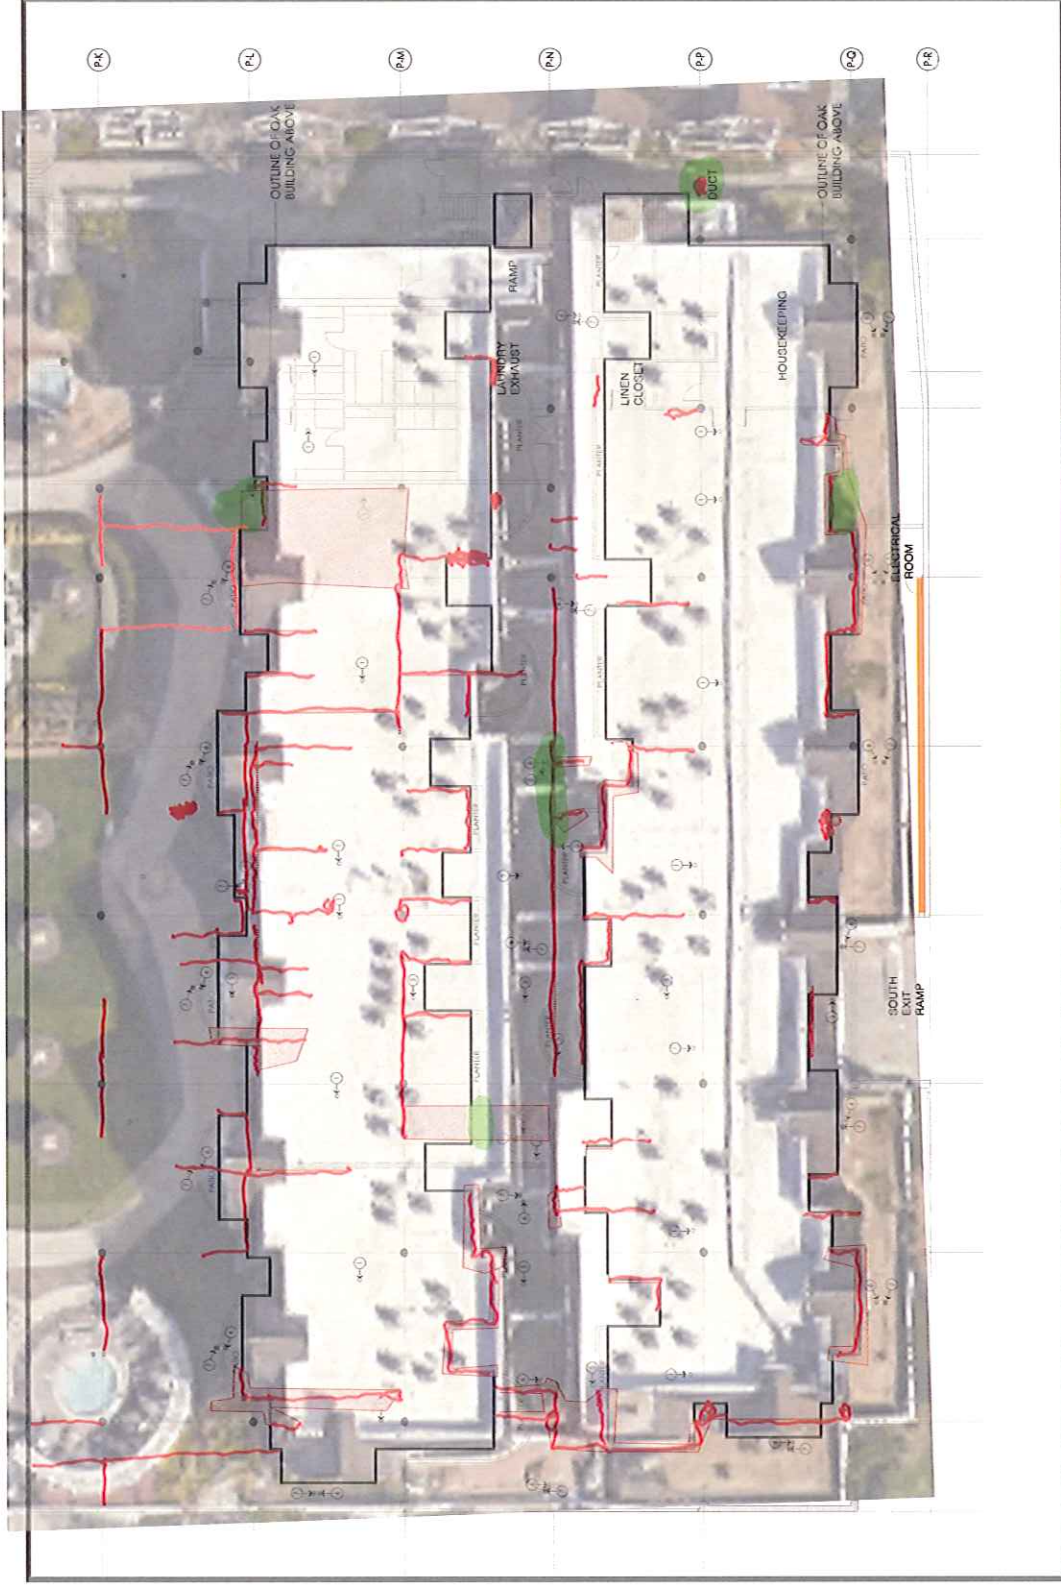
1 PARTIAL GARAGE PLAN - EXISTING
 SCALE: 1/8" = 1'-0"

- IV) With this summary memo, we are submitting sheets G1.2, G1.3 and G1.4. These drawings denote the locations of observed water intrusion and the recommended locations for excavation, exposure of the waterproofing system and documentation of that condition. The recommended areas for destructive investigation are based on the level of water damage observed at the garage ceiling with a variety of possible causes. Any new information obtained could affect these recommendations.
- V) Per David Reed's observations and evaluation, it is most probable that the planters that are located adjacent to the buildings are responsible for the most water intrusion. This may be from planter drains, substrate cracking or non-functioning waterproofing membrane. Other areas of concern are walkway area drains, spa leaks and landscaped area waterproofing membrane.

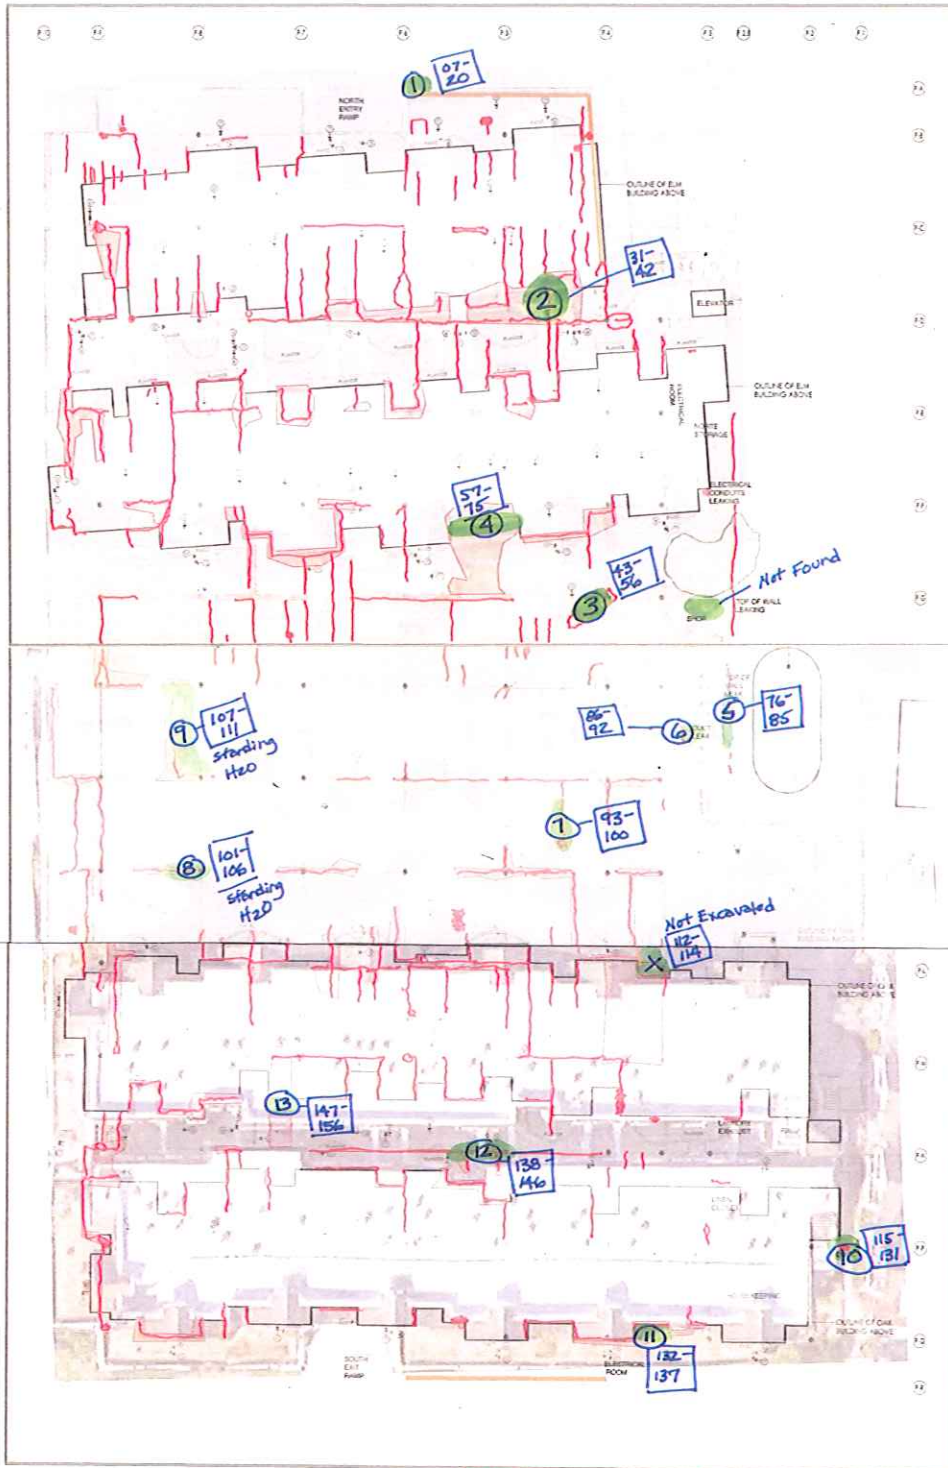
3 PARTIAL GARAGE PLAN - EXISTING

Fifteen separate test pits were recommended and their general location is shown on the attached sheet SK-1. The actual test pits were provided by CIR. On October 03, the test pits had been completed and RC visited the site to document the condition of the waterproofing. BWE and CCA visited the site on October 04.

- In the following test pit locations, the membrane was either found to be non-existent or the membrane thickness was inadequate - test pits 2, 3, 5, 7, 11, 13, 14 and 15.

- No protection board was installed at test pits 5, 6, 7, 8, 11, 12, 13, 14 and 15.
- At test pits 3, 4, 8, 11 and 13, the membrane was in place but the adhesion of the membrane, either to the concrete or between layers of membrane, was either inadequate or non-existent.

- Standing water was encountered in test pits 9 and 10 making documentation of the existing conditions difficult. And at test pits 11 and 12, wetness was observed between the membrane and the concrete podium.

- No filter fabric was observed to be installed at test pits 2 through 10.
- Three test pits were provided adjacent to planter walls allowing observation of the vertical waterproofing system applied to the walls. In all three of these locations, the membrane was thin and compromised.

None of the test pits revealed an adequate waterproofing membrane installation. It is apparent from the observations noted above, that the existing waterproofing systems applied to the podium deck and planter walls at CIR are inadequate and have either failed or in the process of failing. This had resulted in water intrusion through planter walls into residential units and water intrusion throughout the podium deck into the garage below and contributing to the deterioration of mechanical and structural elements that are part of or are supported by the podium deck.

It is our recommendation that the existing waterproofing system at CIR should be replaced. This includes the systems applied to both horizontal (podium slab) and vertical surfaces (planter walls.)
